# ENVIRONMENTAL WETLAND REHABILITATION PLAN FOR BLUE HILLS 105 & 106 AGRICULTURAL HOLDINGS IN, MIDRAND, GAUTENG PROVINCE

**FOR OMEIDA 426CC**

Date Issued: 22 April 2024

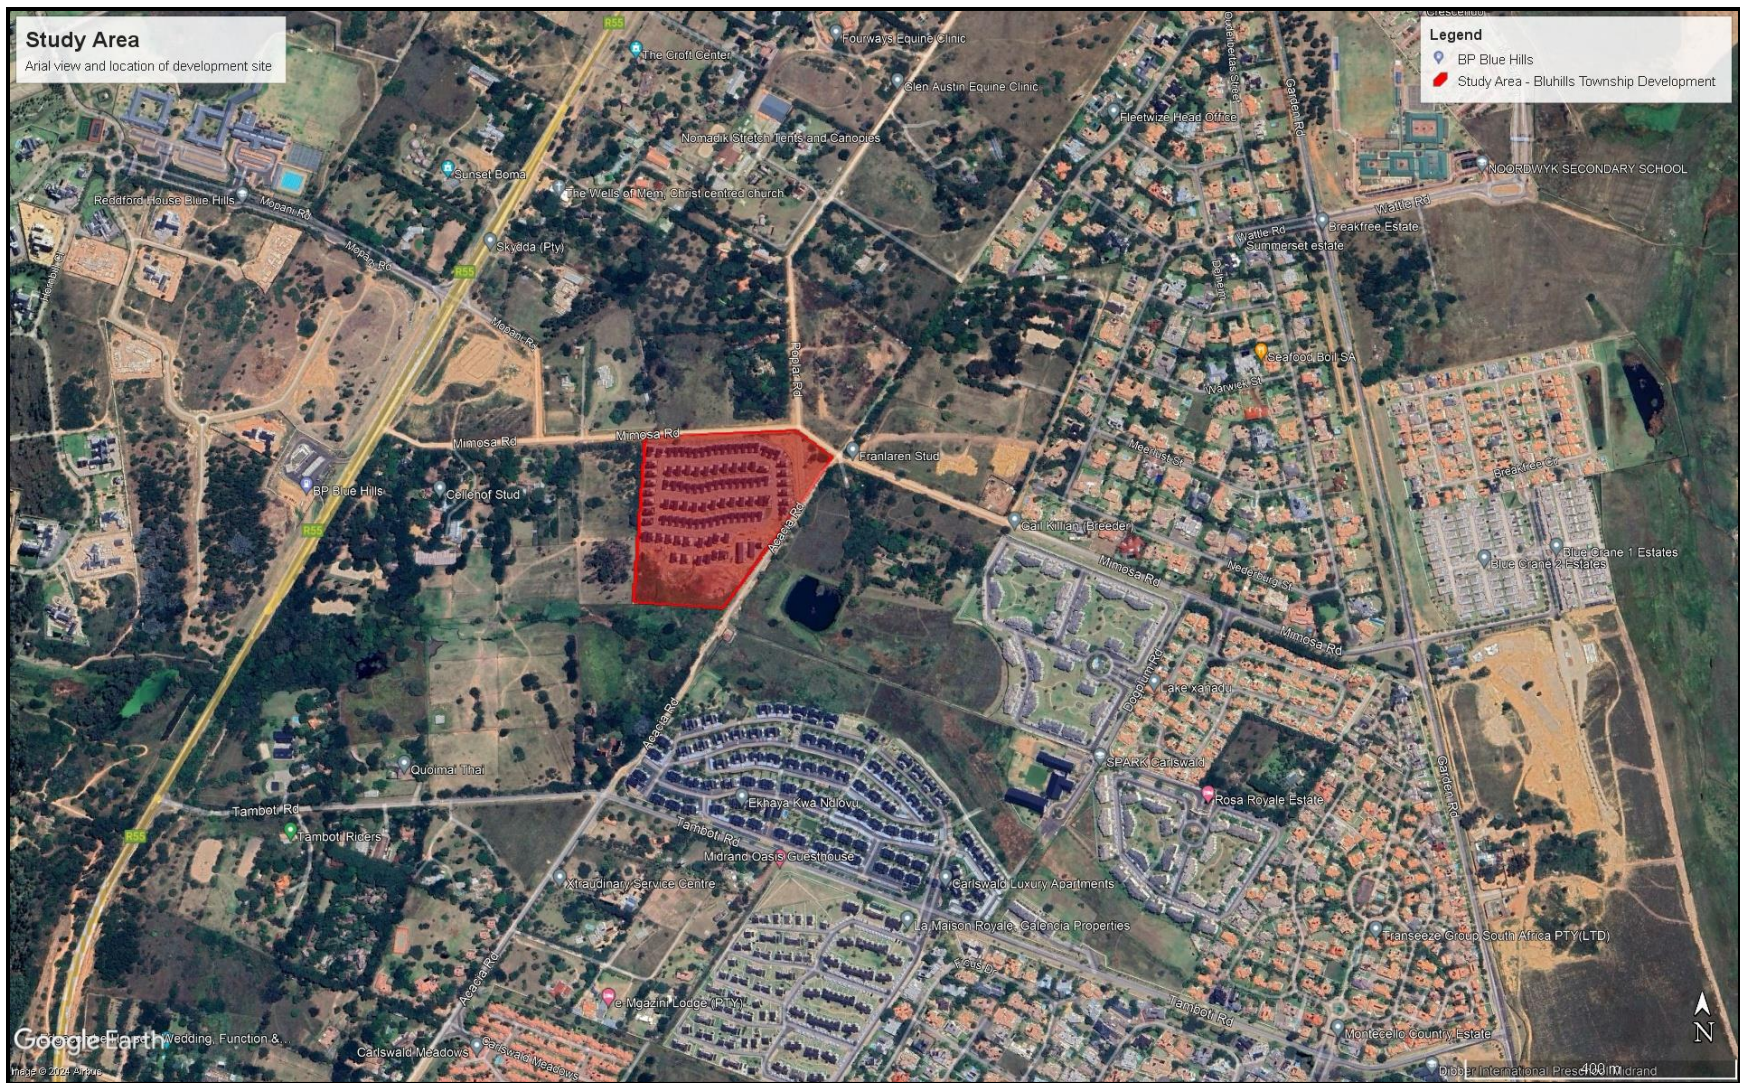
Figure 1: Aerial View of the Project site

Figure 1 shows the aerial view of the study area and the surrounding land uses. Table 1 provides details of the project location.

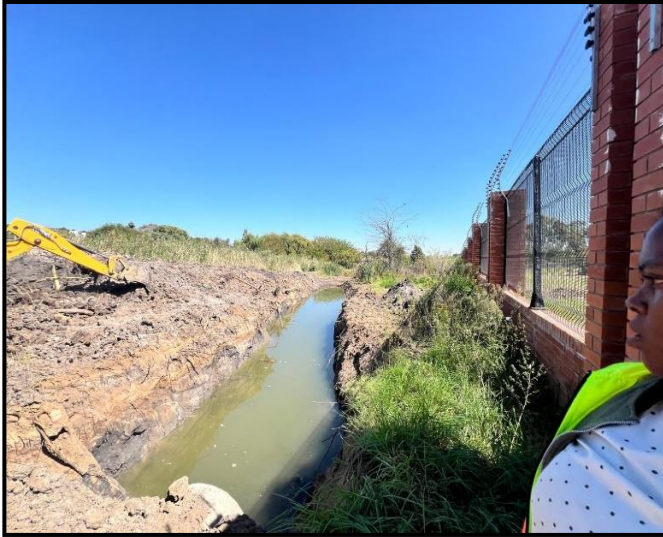
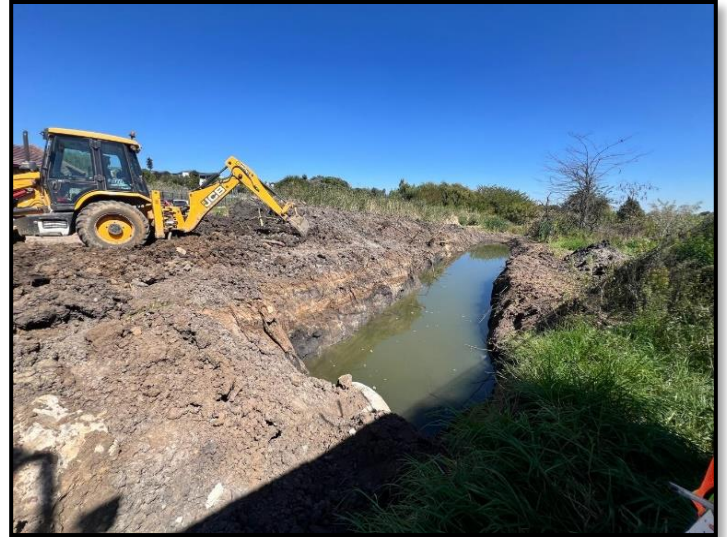
Figure 2: images of ditch dug in wetland -impact to be addressed

- A ditch has been dug in the permanent zone of the wetland – As part of the stormwater drains installation construction activities, a ditch was dug within the permanent zone of the wetland. The impact of this is that this open ditch draws water along its gradient, thus robbing the wetland downstream of water and altering the even spread of floodwater over the width of the wetland. See Figure 2.

| Observed Impacts | Target | 1. Rehabilitation Actions | Timeframe |

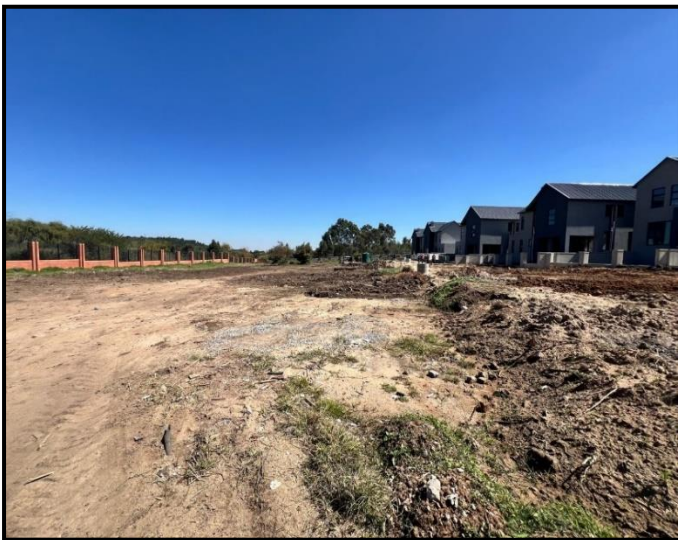
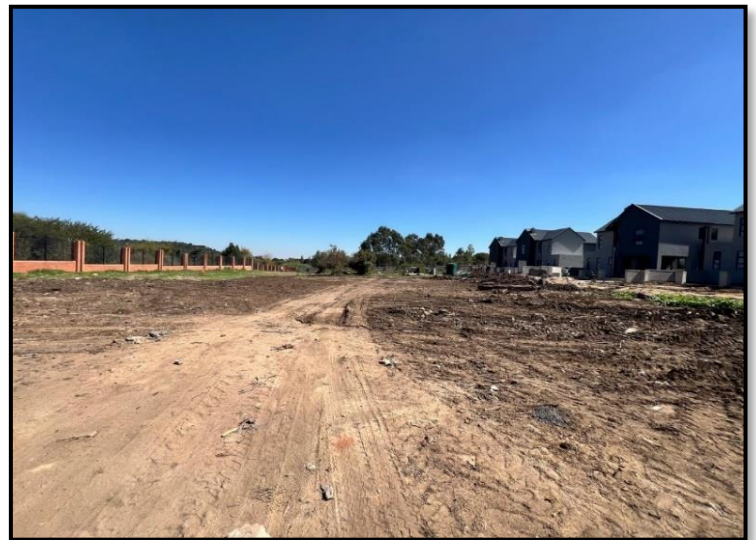
Figure 3: Vegetation clearing on portion of wetland inside property

- Vegetation clearing – There is a portion of the wetland that traverses the property, this was supposed to be demarcated as per environmental authorisation however, this was not done and there was vegetation clearing and stockpiling of construction material. There was also vegetation clearing and stripping of topsoil along the access road. See Figure 3.

Table 3: Site 1 - Area within the boundary of the property cleared of vegetation on the wetland.

| Observed Impacts | Target | Rehabilitation Actions | Timeframe |
|---|---|---|---|
| <ul style="list-style-type: none"> <li>Wetland vegetation clearing (loss on natural vegetation)</li> <li>Stockpiling and rubble dumping</li> <li>Soil compaction</li> </ul> | <ul style="list-style-type: none"> <li>Complete site clean-up.</li> <li>Reinstate and rehabilitate areas disturbed by construction activities.</li> <li>Achieve 75% coverage for areas that have been grassed or hydroseeded.</li> <li>No bare patches exceeding 0.25m<sup>2</sup> in an area of 1m x 1m.</li> </ul> | <ul style="list-style-type: none"> <li>The wetland area inside the boundary of the property must be properly demarcated to prevent further degradation and impacts as per the condition of the EA.</li> <li>To begin rehabilitation of the area, all remnants of foreign debris should be removed from the site. These include plants, and construction rubble &amp; debris.</li> <li>All rubble and debris on site is to be collected and removed from site and disposed of at a licensed waste disposal site. The ECO must be provided proof of disposal in the form of an invoice from the contractor, or a weighbridge notice from the relevant disposal site.</li> <li>Alien invasive species that are identified within the servitudes should be removed prior to construction related soil disturbances. This will prevent seed spreading into disturbed soils.</li> <li>Manual / mechanical removal is preferred to chemical control. If herbicide must be used it should be registered for aquatic use.</li> </ul> | Immediately |

| Observed Impacts | Target | Rehabilitation Actions | Timeframe |
|---|---|---|---|
| | | <ul style="list-style-type: none"> <li>▪ Compacted soil should be ripped to a depth of more than 150 mm.</li> <li>▪ The final prepared surface should not be smooth but furrowed to follow the natural contours of the land.</li> <li>▪ Do not permit vehicular or pedestrian access into natural areas or into seasonally wet areas during and immediately after rainy periods, until such a time that the soil has dried out.</li> <li>▪ Reshape and reprofile the wetlands in order to achieve a natural topography.</li> <li>▪ Redistribute stockpiled topsoil across the wetlands.</li> <li>▪ Implement erosion control measures within newly worked, bare areas in order to prevent the loss of topsoil due to wind and water erosion. These areas may be covered with geotextiles.</li> <li>▪ Do not remove temporary erosion protection materials until the vegetation cover has re-established.</li> <li>▪ Revegetate the wetlands with the indigenous wetland species as listed below as soon as possible after the application of topsoil and stabilizing of soils: <ul style="list-style-type: none"> <li>○ <i>Bulbostylis hispidula</i></li> <li>○ <i>Cyperus dives</i></li> <li>○ <i>Cyperus laevigatus</i></li> <li>○ <i>Cyperus sexangularis</i></li> <li>○ <i>Juncus dregeanus</i></li> </ul> </li> </ul> | |

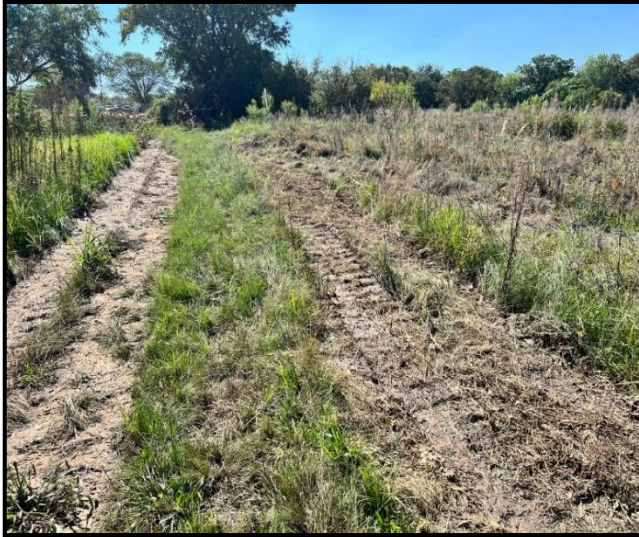
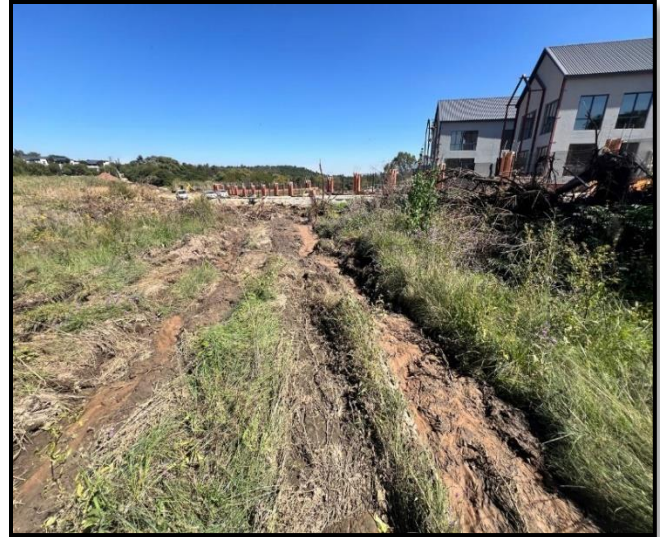
Figure 4: Impact of excavator moving on wetland in private property

- Change in ground cover/impact on land- While attempting to load an excavator on a flatbed, the excavator entered private property adjacent to the construction site. There was a disturbance in the ground cover which exposed the wetland soil and cleared vegetation. See Figure 4.

Table 5: Site 3: Rehabilitation actions

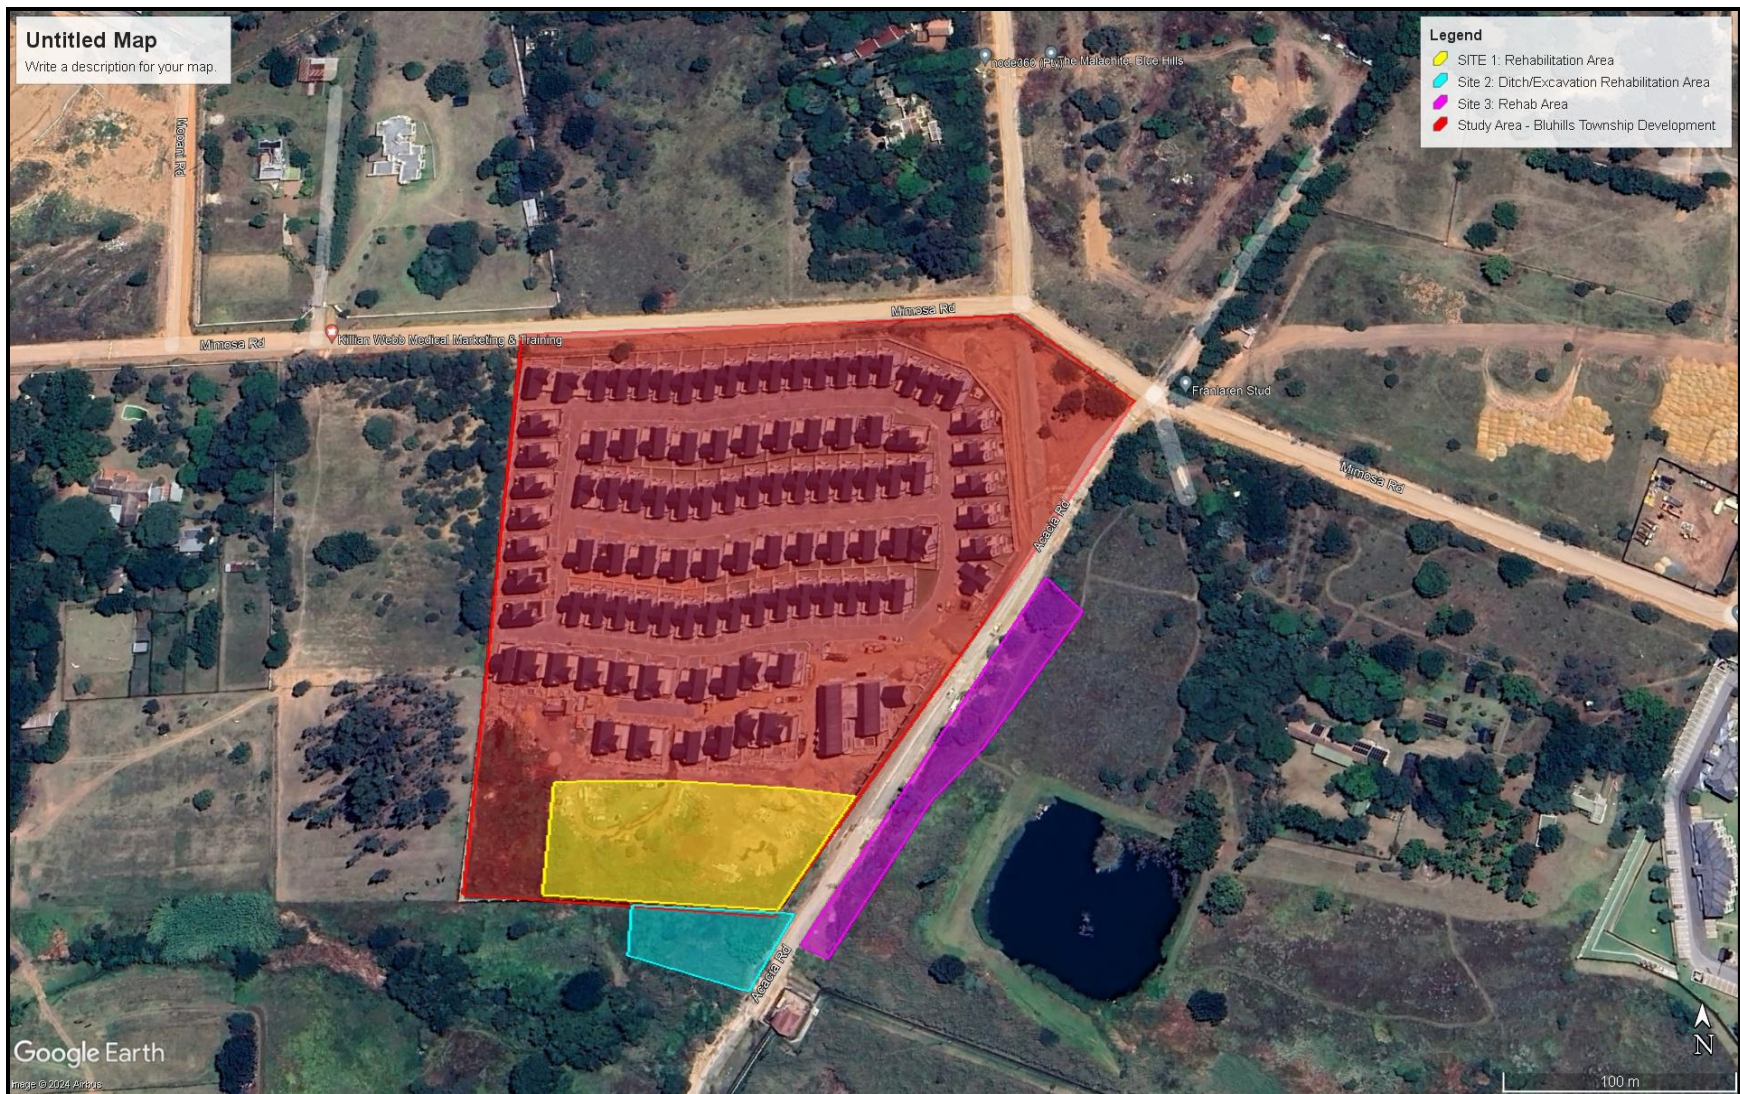
## MAP REHABILITATION SITES

The activities involved in the Rehabilitation Action Plan are discussed according to the different needs of the impacted areas identified for rehabilitation and these components (areas) are detailed in below and a map of these components is provided in Annexure 1.
